City of Detroit
Department of Recreation Performance Audit
Exhibit 1 – Maheras Center

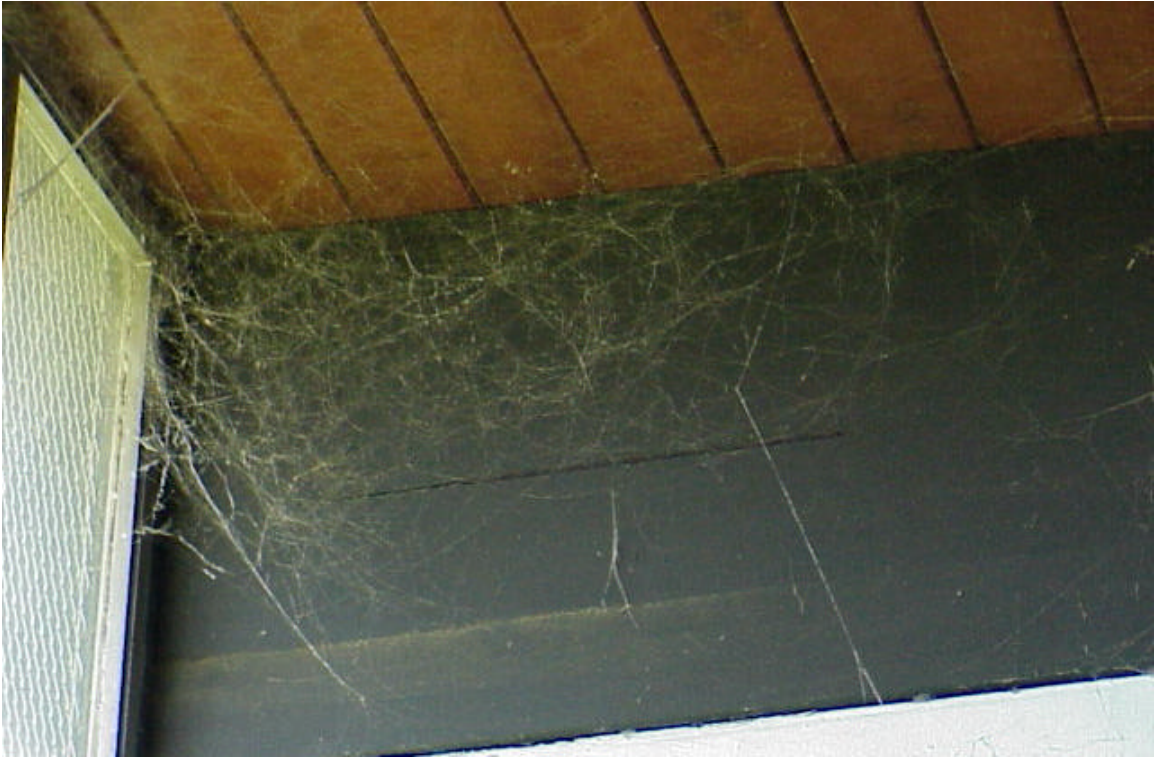
Cobwebs in the corner.

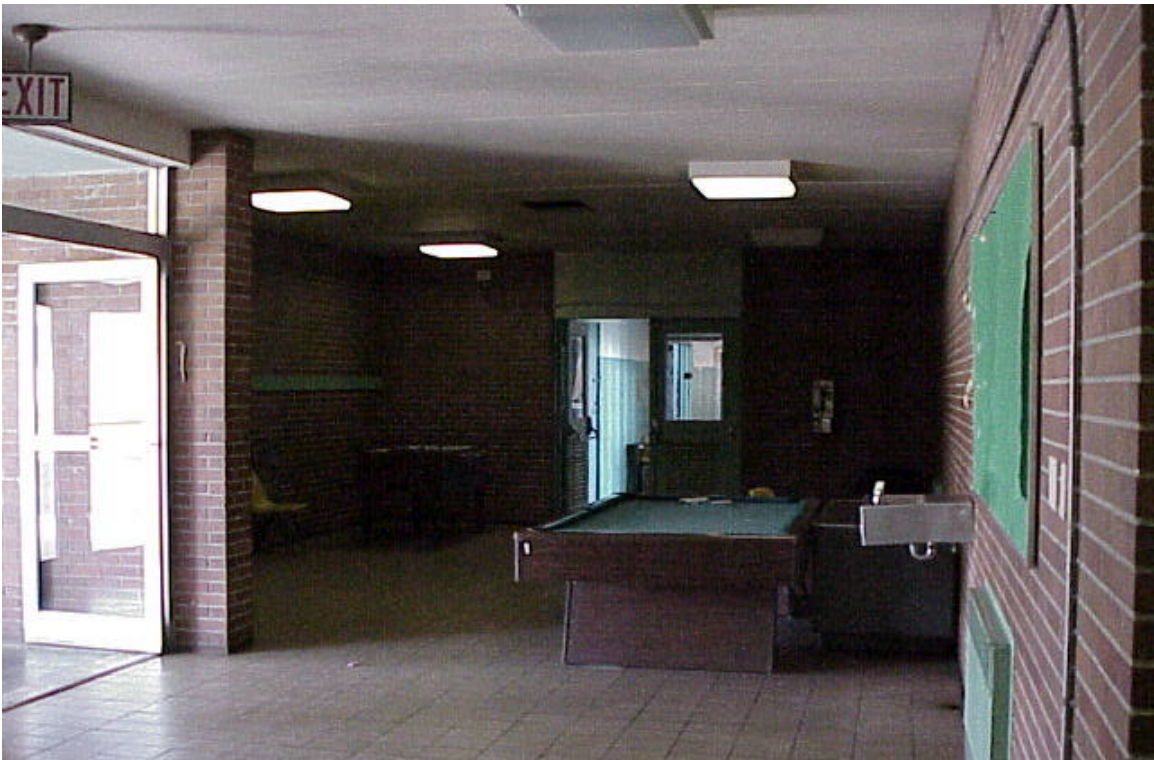
Dimly lit hallway.

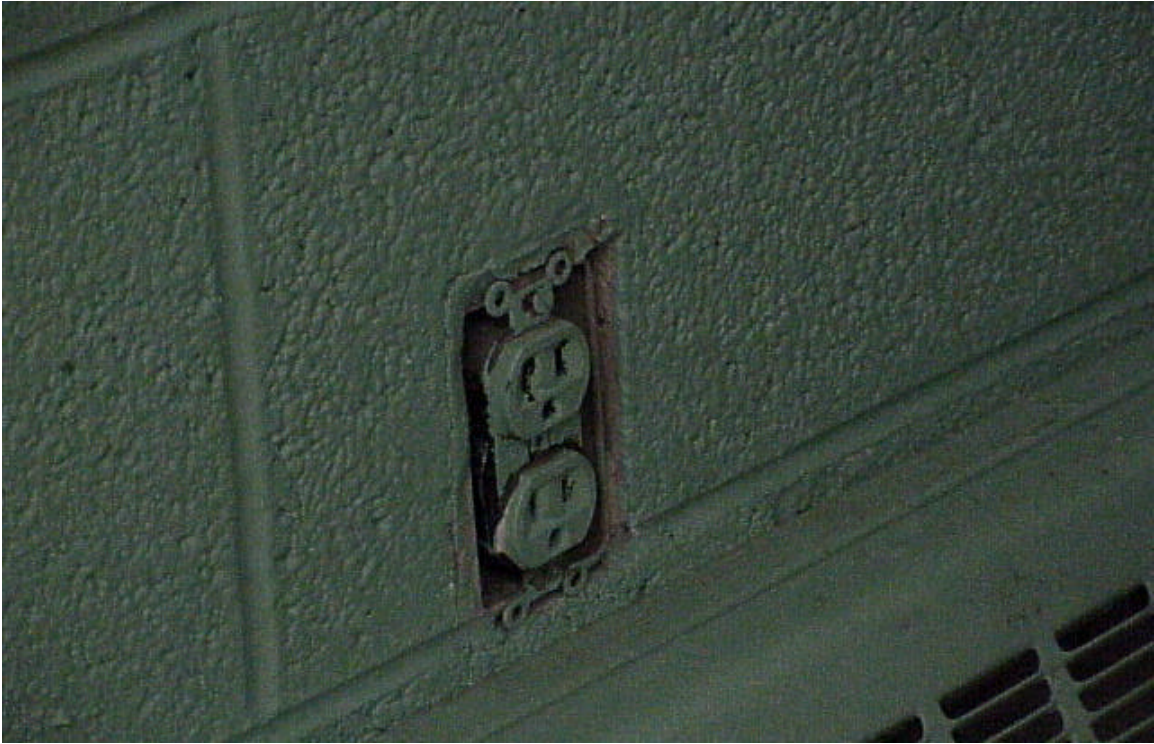
Exposed electrical outlet.

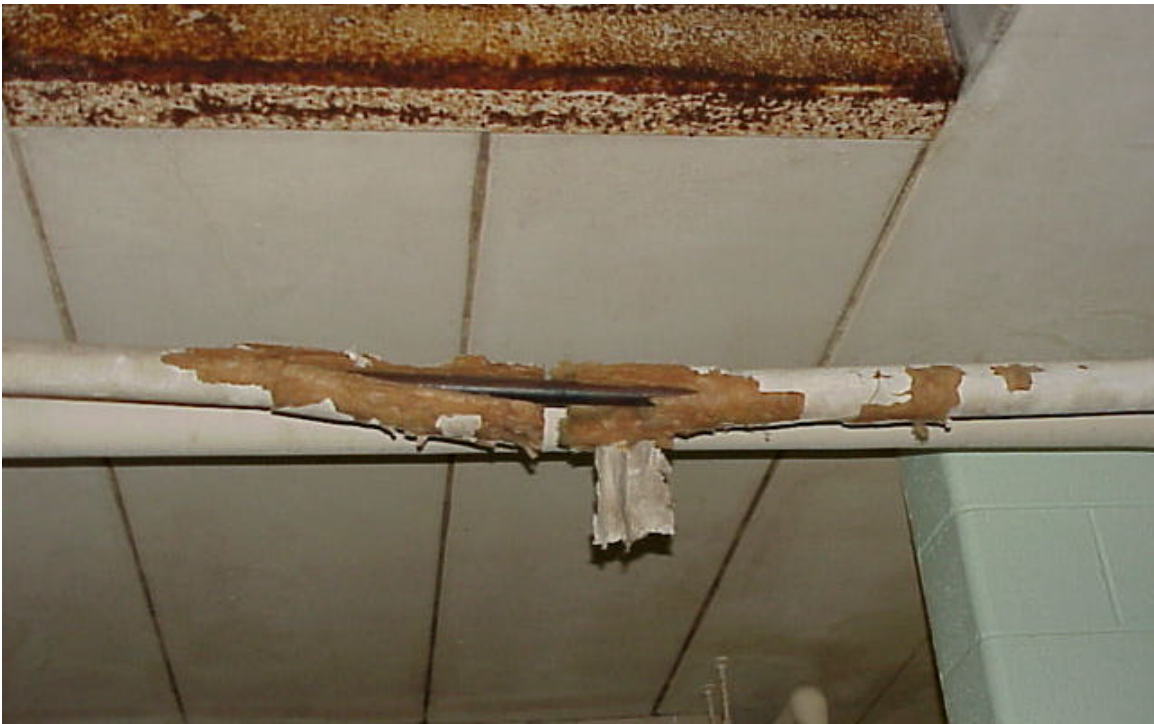
Exposed pipe due to deteriorating insulation.
